Patient Safety Alert

AL09-21

May 4, 2009

ATTACHMENT 1: Short term mitigation procedure from Arjo Corporation

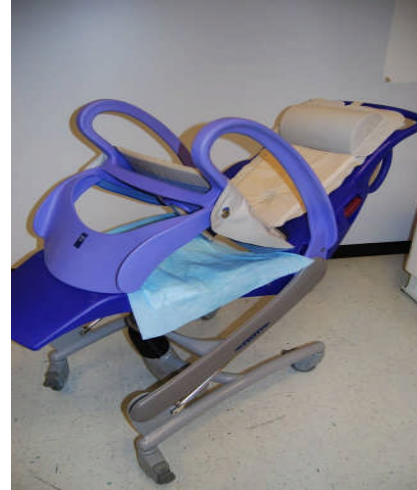
VA Carendo Shower Chair Application for Incontinent Patients Step #1 of 2

- When the Care Raiser is in a fully-raised position, place a chux across the bottom seat portion of the lift, beneath the Care Raiser seat, to avoid pinching of male genitalia of incontinent Patient or Resident.

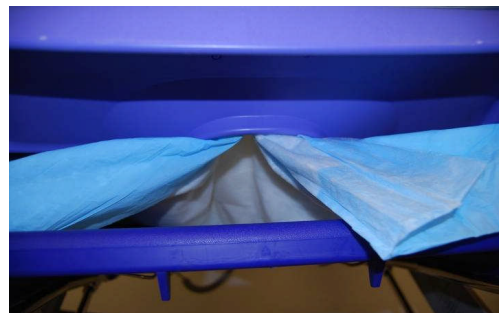
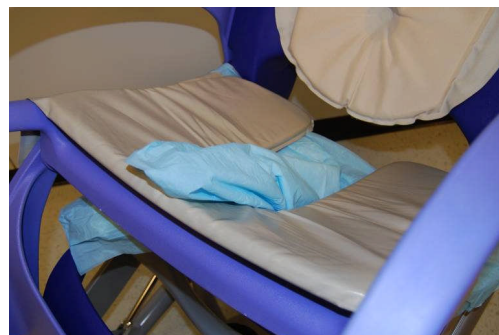
VA Carendo Shower Chair Application for Incontinent Patients Step #2 of 2

- To avoid pinching of male genitalia of incontinent Patient or Resident, pull the chux up through the front of the u-shaped opening of the Care Raiser seat.
- Insure that the Patient or Resident is comfortable before proceeding to lower the Seat

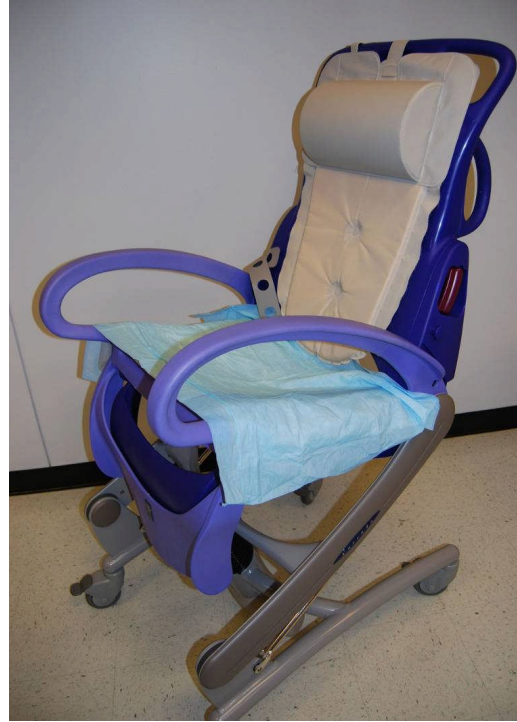
**VA Carendo Shower Chair application
for Continent Patients**

- To avoid pinching of male genitalia with Patient or Resident that is continent, the chux can be placed across the seat of the Carendo before the resident is placed in the chair, adding to the comfort of the resident.
